The Amorium Project: The 1995 Excavation Season

C. S. LIGHTFOOT AND ERIC A. IVISON*

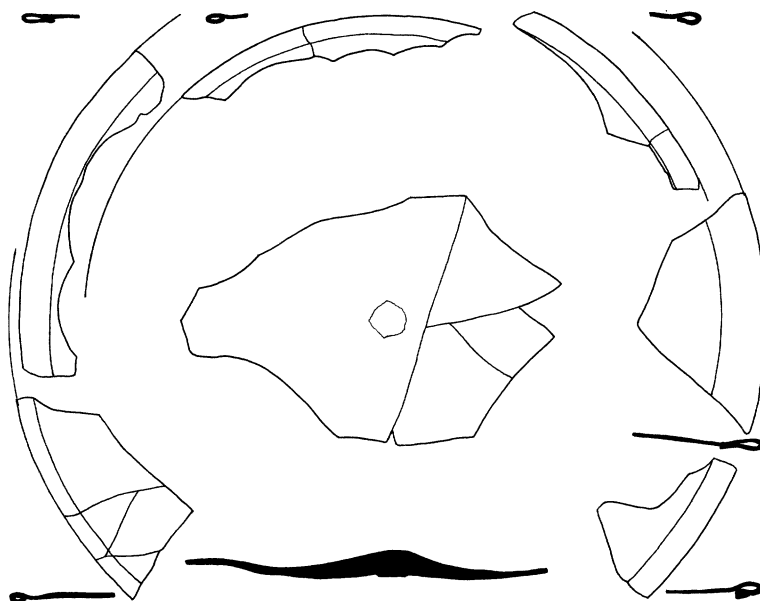
Fig. C Fragments of bull's-eye window panes found in the Lower City church (scale 1:2) (drawing by M. Gill)

Large quantities of broken window glass were also found in the central bay of the north aisle; some of these fragments joined with the bull's-eye panes still in situ in the plaster. Three rim fragments of widely differing dimensions were found still embedded in the plaster that had originally framed them, their diameters being approximately 24 cm, 20 cm, and 10 cm. From the same area as the plaster frames came fragments of rims with diameters ranging from 16 to 20 cm, with various widths of folded rim and slight variations of color within the range of colorless, colorless blue-green, and blue-green colorless (Fig. C). Also found in the same context was a complete bull's-eye, restored from four separate pieces. This is sufficiently large to indicate that the profile of an entire circular pane would have been comparatively flat, that is, platelike rather than bowl-shaped. The smallest pane embedded in plaster has a plain rim; the remainder of the rims from this season's excavation are folded, usually with a simple backward fold but sometimes with a more complex return, the signature, perhaps, of a master glassblower.¹³ One should also note the existence of one fragment of crown glass that is purple in color, perhaps indicating that the Amorium church was furnished, at least in part, with stained glass.¹⁴ These fragments provide valuable new information about the production of Byzantine window glass and add further confirmation to the view that the craft existed quite independently of western traditions.¹⁵

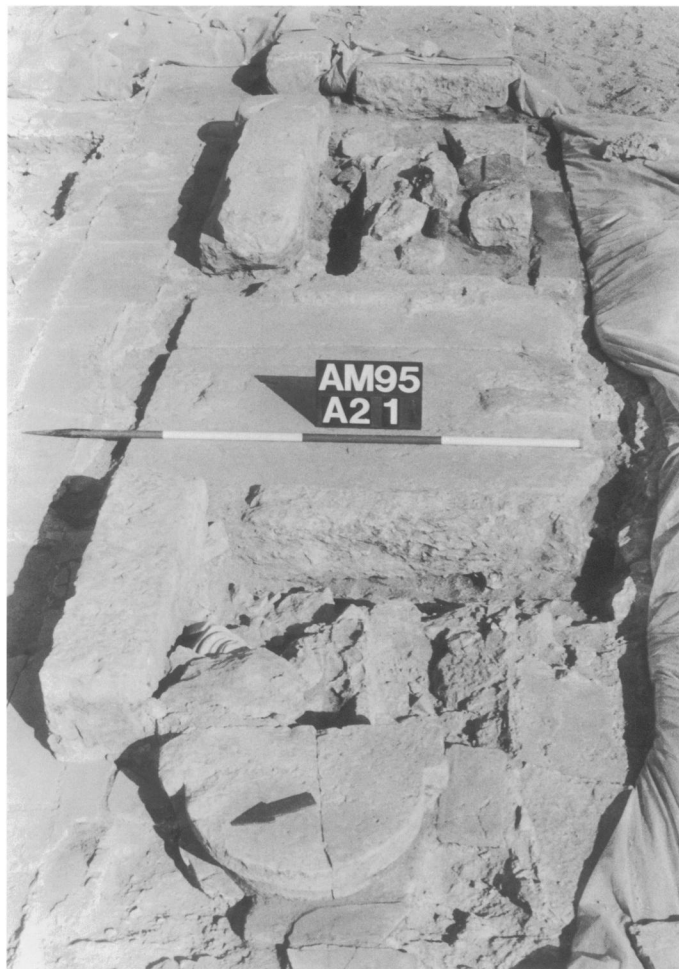
1 Lower City church, ambo foundation (Neg. AM95/11/7A)

The excavation of the Phase II ambo foundation was also completed during the season (Fig. 1). This was better preserved on its north side, providing valuable information about its construction. It seems that the ambo was laid out on the site of its predecessor in the middle

of the naos, being directly beneath the main dome of the Phase II basilica. It follows the standard design, found throughout the Byzantine world, consisting of a central raised superstructure approached by staircases to the east and west. A huge foundation pit was dug through the earlier pavement, perhaps to the foundations, to accommodate a reused door threshold. This massive slab acted as a very solid support for the raised central superstructure, which was the heaviest part of the ambo. The staircases were built on the Phase I foundations or surviving blocks, such as that of the east staircase, which remained in situ. Other staircase foundation blocks were cemented to Pavement B, showing that the construction of the ambo took place in two stages: the larger foundation blocks were put in place before Pavement B was laid, while the minor elements and superstructure were inserted after the pavement was largely finished. The interior of the staircase foundations was filled with discarded marble scraps and chippings, fieldstones, and other building debris, including a broken white marble baluster post, presumably part of the destroyed Phase I furnishings. Other blocks, found in Seljuk levels, may be treads from these staircases. The central superstructure seems to have been roughly square and probably had a paneled lower story. It is not certain whether small columns helped to support this central part, for there are no markings for them on the surface of the foundation block.

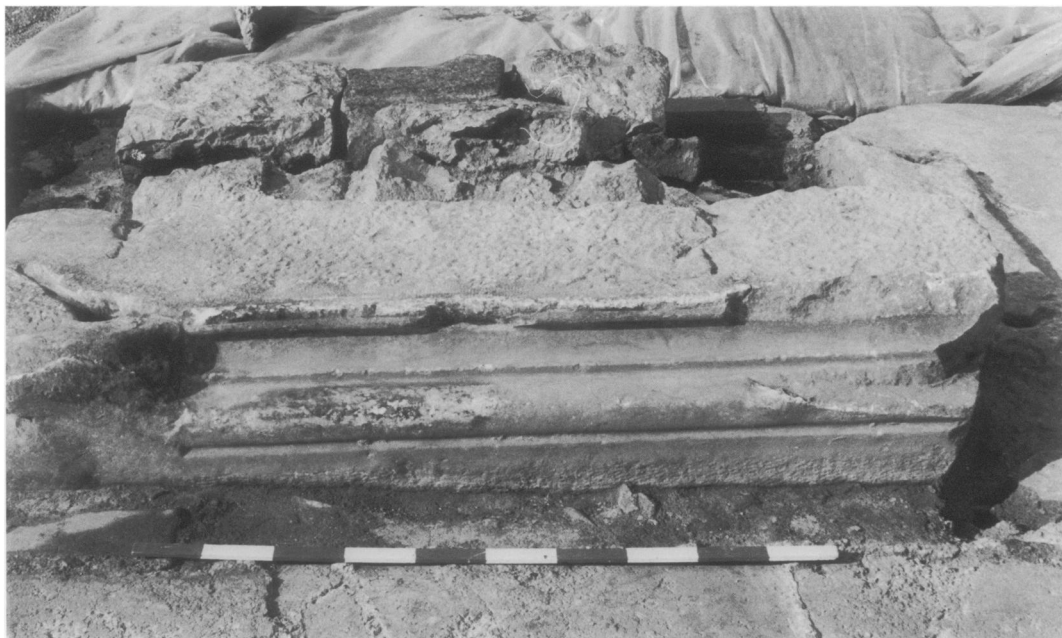
2 Lower City church, detail of block in ambo foundation (Neg. AM95/13/22)

The site of the Phase I ambo is occupied by its middle Byzantine successor, and consequently most traces of the former have been obliterated by the latter's foundations and particularly by the massive threshold that acted as its central support (Fig. 1). A robbed foundation under the Phase II west staircase may, however, be part of the late antique structure, for the impressions of foundation blocks are still visible. It also seems likely that the north block of the eastern staircase is still in situ, for it is enclosed by the middle Byzantine Pavement B. This block (Fig. 2) is of white marble, with a cable and cavetto molding similar to the Phase I templon stylobate. Its eastern surface is worn from the frequent passage of feet and has a dowel for siting a baluster post. The rest of the block's top surface is roughened for the siting of the stair rail and treads. Another staircase foundation block identical to that still in situ was found in the south naos in 1993. Another fragment from the curved central portion of this ambo was also found this year, the moldings of which closely correspond to the staircase foundation blocks. Other fragments that may belong to this late antique ambo have

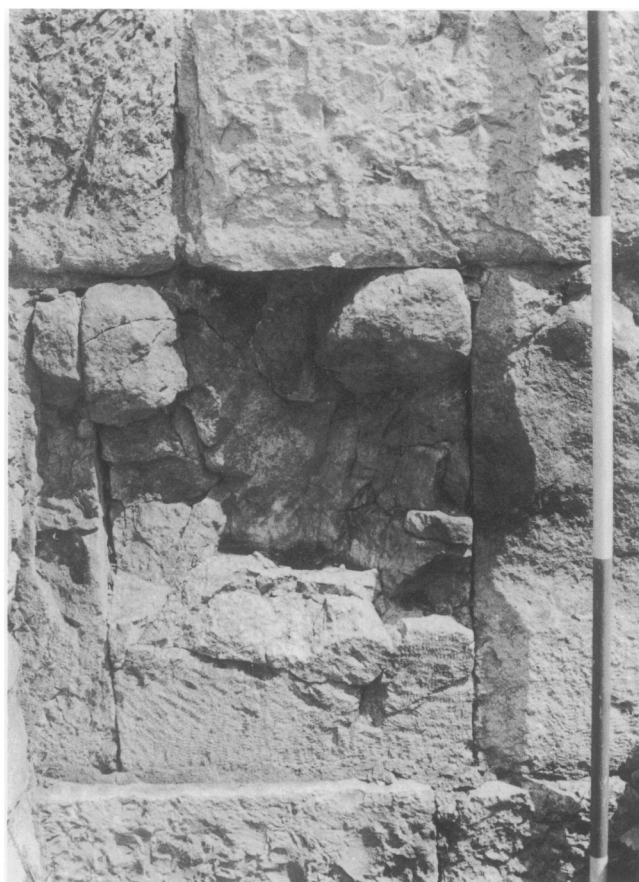
3 Lower City church, detail of fire-damaged block in main north wall (Wall 7) (Neg. AM95/13/28)

Evidence for the destruction of the Phase I basilica by fire was recognized this year on the interior faces of Phase I walls. Large areas of Walls 7 (Fig. 3) and 47 and a portion of the apse were found to be blackened by smoke and to be shattered as the result of exposure to extreme heat. This damage must predate the middle Byzantine rebuilding, as it was sealed by the piers of the Phase II church and concealed by the earliest layer of fresco. Efforts had also been made during the rebuilding to patch up the most seriously affected areas with plaster. Blackened Phase I blocks, presumably from demolished walls, were also jumbled up among the spolia in the Phase II piers. The lower parts of the Phase I walls were the most badly damaged and blackened, suggesting that wooden roof beams had collapsed against the walls and continued to burn as they lay at floor level. The same phenomenon was observed in 1993 during the excavation of the massive destruction layer in the triangular tower on the Lower City walls.⁶ The fire damage to both structures helps to explain in part the poor condition of the exposed stonework.

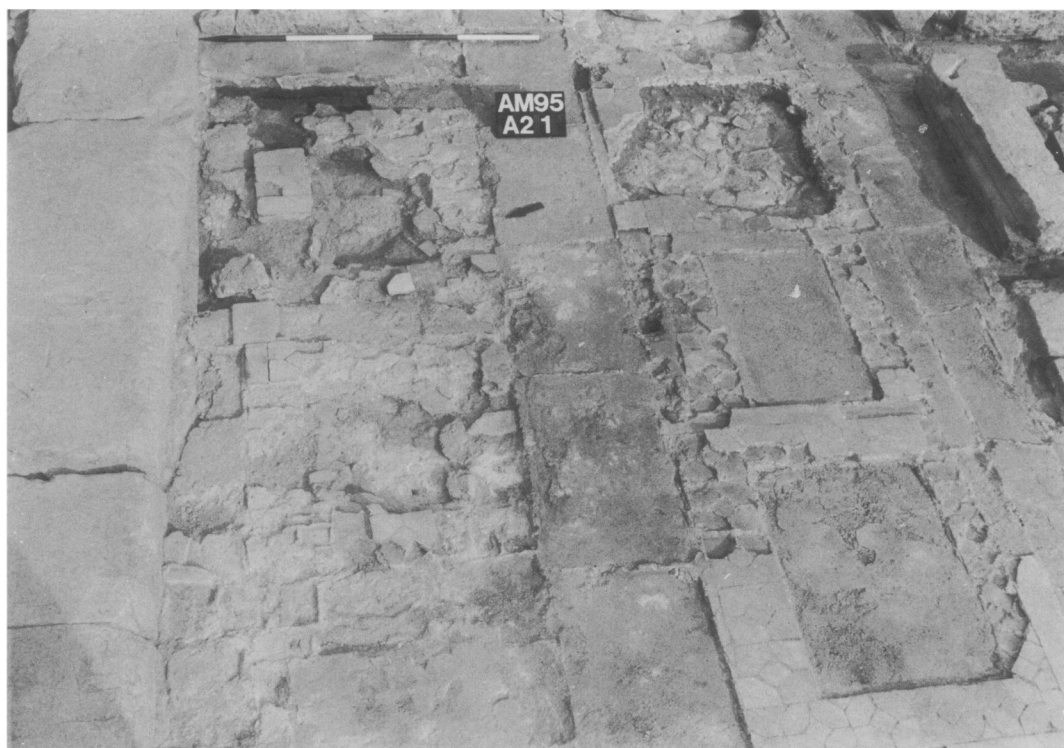
4 Lower City church, central section of Pavement B to the north of the ambo (Neg. AM95/11/11A)

Pavement B was found to be in a better state of preservation on the north side of the naos than on the south (Fig. 4). Almost all of the large slabs had been removed in the post-Byzantine period, but their frames and mortar beds were largely intact. As found elsewhere in the church, Pavement B was separated from the late antique Pavement A by an earth packing, which in the naos was visible in a number of pits through the mortar bedding. This earth fill was largely sterile and extremely hard, having been compacted between the pavements. Under it was found a loosely packed jumble of crushed stone rubble, coarsely cemented together. Whether this represents a foundation for Pavement A, which has been completely removed, or another layer of stone packing, such as that encountered in the bema, is not yet clear. The cement beds and slabs of Pavement B in the naos were thinner than in the bema, nor were any stone wedges visible to help support the large slabs.

Pavement B was carefully designed to fit the naos and the crossing under the main dome. In the naos proper the pavement has a strictly axial east-west design, laid out to either side of the ambo, which occupied the center of the church (Trench A2-1). As found at the west end, the design was of large rectangular slabs surrounded by frames of small marble tiles cut into a variety of geometric shapes. These shapes included lozenges, squares with cutoff corners, and triangles, usually arranged in repetitive panels. Long rectangular slabs divided the main naos at a line drawn between the arch of Piers 52 and 55. North of them the pavement was divided into three panels, again composed of rectangular slabs of marble but surrounded by more complex frames of geometric tiles. To the north the pavement was bordered

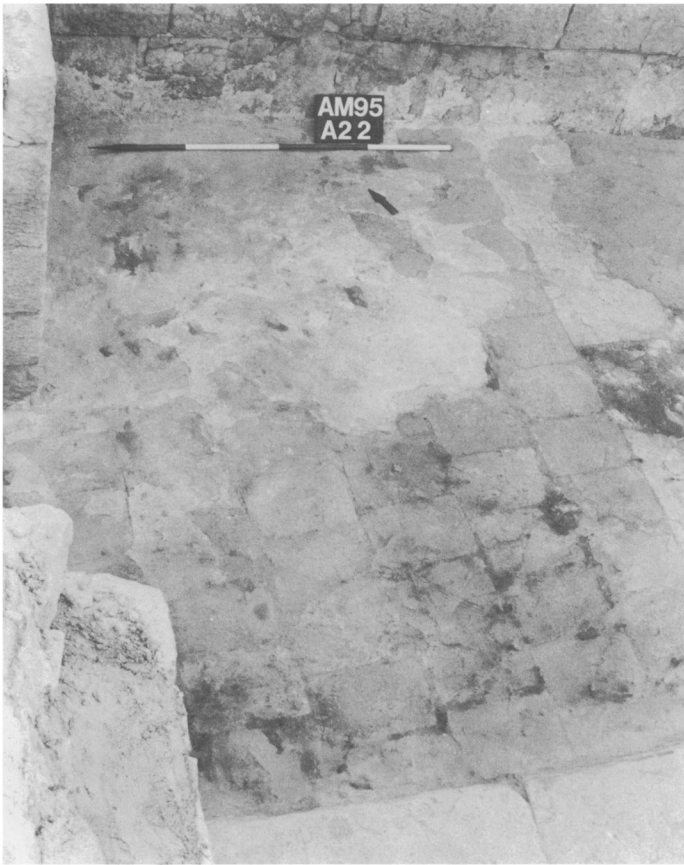
5 Lower City church, tile floor in the central bay of the north aisle (Neg. AM95/11/15A)

The pavement in the central bay of the north aisle (Trench A2-2) was also paved with terracotta tiles. This forms part of a continuous pavement running the whole length of the north aisle.⁹ The pavement is best preserved at the sides to east and west, where it continues through to the intercommunicating bays. In the western half of the bay it is made up of rectangular tiles, while in the eastern part the tiles are square. Although the tiles have been badly cracked, it is clear that the pavement was laid with care, as in the case of that in Trench A1. In the northwest corner the pavement and walls had been heavily whitewashed (Fig. 5). Several coats are visible, and they extend without interruption from the lower walls down onto the pavement, indicating that they were applied at the same time. The significance of this whitewash, which shows no sign of paint, is not yet known. It may constitute a late repair, but it seems restricted in its location, as no traces of it have been found on other walls that still retain patches of painted fresco.

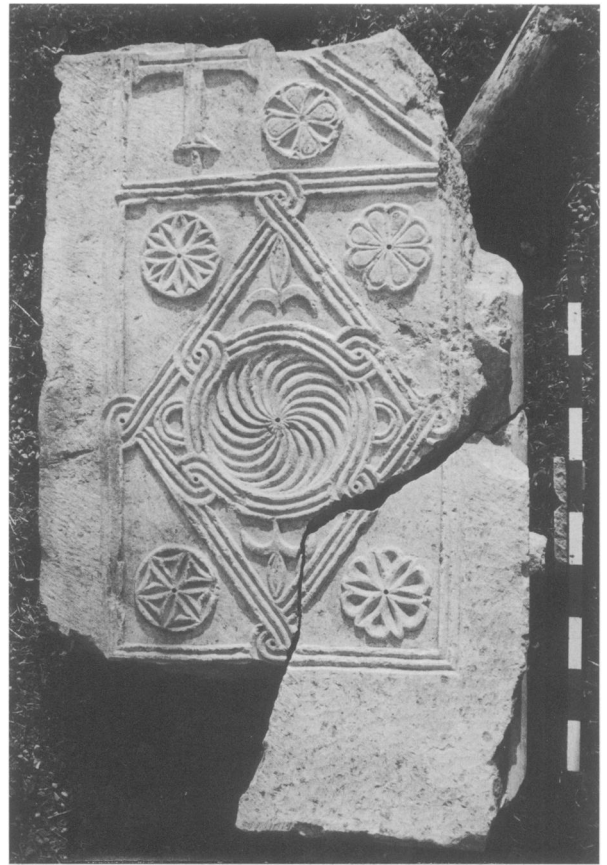
6 Lower City church, ambo parapet slab (T750, joined with T130) (Neg. AM95/11/16A)

Although large fragments of carved panels commensurate in size with an ambo had previously been recovered from the church, no conclusive proof of their identity was found until this year.¹⁰ The discovery of a well-preserved staircase parapet (Fig. 6), with its handrail partially intact, permitted the attribution of a large number of pieces, some joining with others from previous seasons. All are of matching bluish-gray marble, many recarved from late antique door frames. The pieces also form a set on the basis of matching style, motifs, and carving technique. At least two staircase parapets (of the set of four needed) have been recognized, together with several massive composite pieces, which probably revetted the

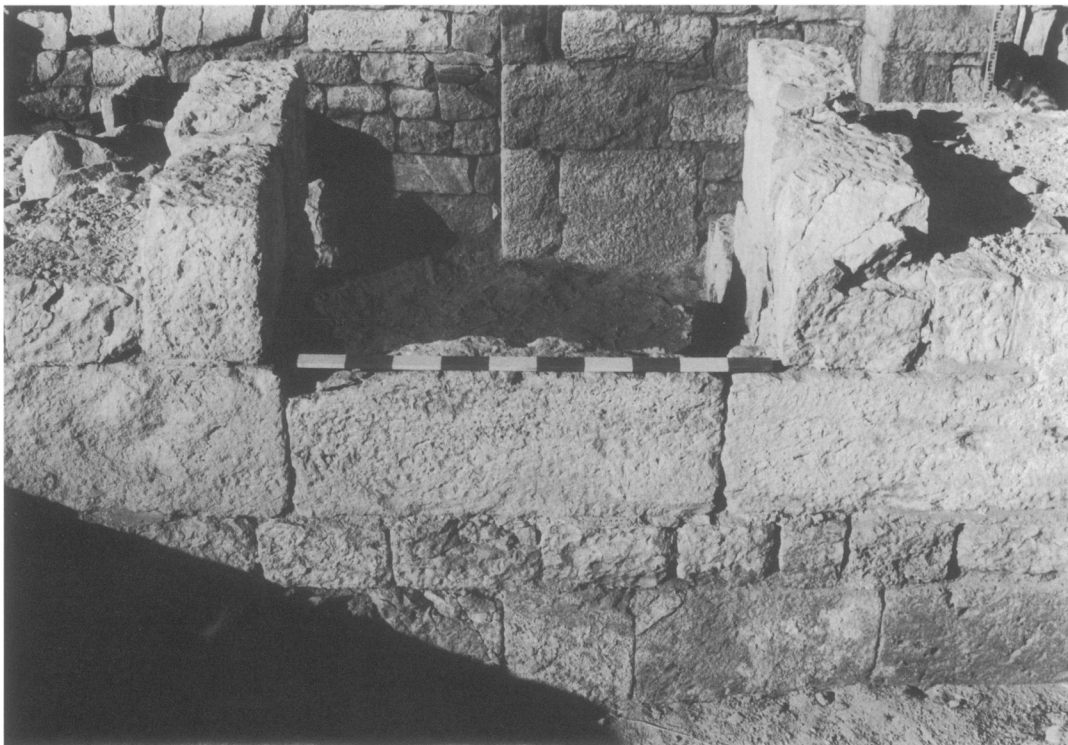
7 Lower City church, window recess in main north wall (Neg. AM95/07/34)

It seems likely that the middle Byzantine church continued to use at least some of the late antique window openings in the outer aisle walls, for two windows are still extant in the main north wall (Fig. 7), while several detached windowsills can be found scattered in and around the building. Fragments of molded plaster window frames were among the most unusual of the season's finds. All of them were found in Seljuk levels, some apparently fallen from their settings in the walls above. Owing to the fragile nature of the material, these plaster frames were very fragmentary, but it is clear that they had been pierced by cusped roundels, some open, others framing circular panes of bull's-eye glass. The exteriors of the frames had been incised with shallow hatched and drilled decoration, some of which had also been highlighted with red paint. Similar molded plaster window frames are known from the eleventh-century Katholikon of Hosios Loukas in Greece and from the apse window in the Parekklesion of the Kariye Camii in Istanbul, but the Amorium frames are the only ones so far recorded from Anatolia.¹²

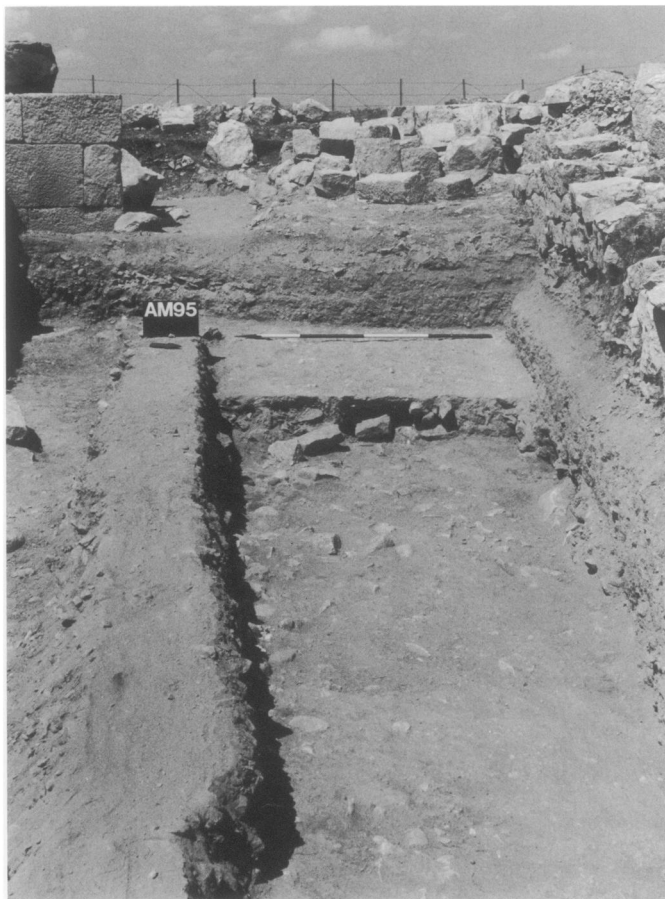
8 Lower City gateway, Trench LC1, road surface
(Neg. AM95/03/0)

Work in the area behind the gateway in the Lower City walls began in 1994. The intention was to uncover the road as it passed into the city and to investigate the nature of the buildings that had flanked the street.¹⁸ In 1995 the trench was given the new title of Trench LC (divided into two sections: LC1 to the west and LC2 to the east) in order to avoid further confusion with Trench AB. As in the previous season, the initial aim was to trace the road that passed through the gate and led off into the city. The surface of the road (Fig. 8) was found to consist of compacted earth and gravel, in which three distinct layers were identified. These were all very similar in appearance, each having roughly the same makeup and thickness (approximately 0.04–0.035 m). The road was found to run off in a gentle slope away from the gateway, having a width of some 3–3.5 m, flanked on either side with a layer resembling that which had been found above it. The road foundations were made of fairly loose rubble. It is clear that the road had been first laid down at the same time as the construction of the Lower City fortifications, since it occurs at the same level as the top of the foundation courses in the wall, and that it was subsequently resurfaced during a long period of use. Part of the road runs beneath a late wall that had been excavated in 1994 (= AM94/AB/Context 204). This does not lie immediately on top of the road surface but is divided from it by a mixed layer of earth. It seems, therefore, that there was an interval during which soil deposits accumulated over the street before the gateway was blocked off by new buildings.¹⁹

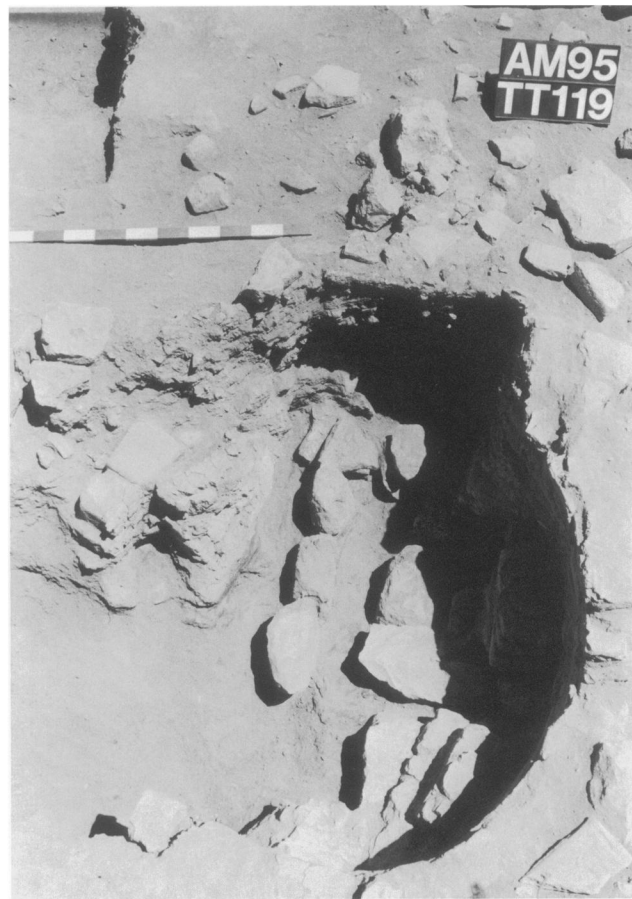
9 Upper City, Trench TT, potter's kiln
(Neg. AM95/08/31)

The exact position of the kiln (Fig. 9) in the stratigraphic sequence is unclear, but it can be placed after the middle Byzantine restructuring of the mound. It would also appear to precede the construction of the wall in Context 74, an extension or addition to another wall (Context 111), based on the assumption that the kiln and other features of the potter's workshop would have operated at a distance from inhabited structures. The kiln, therefore, can confidently be assigned to the tenth or eleventh century; it is hoped that further work in the area in the coming seasons will allow us to date it even more closely.

The kiln will be the subject of a separate, detailed report. It was the object of intensive and careful excavation, in which every context was planned, photographed, and sectioned. In addition, it was sampled for organic and carbon deposits wherever appropriate, and at the end of the season the area was covered and back-filled to preserve the delicate brick structure of the kiln.

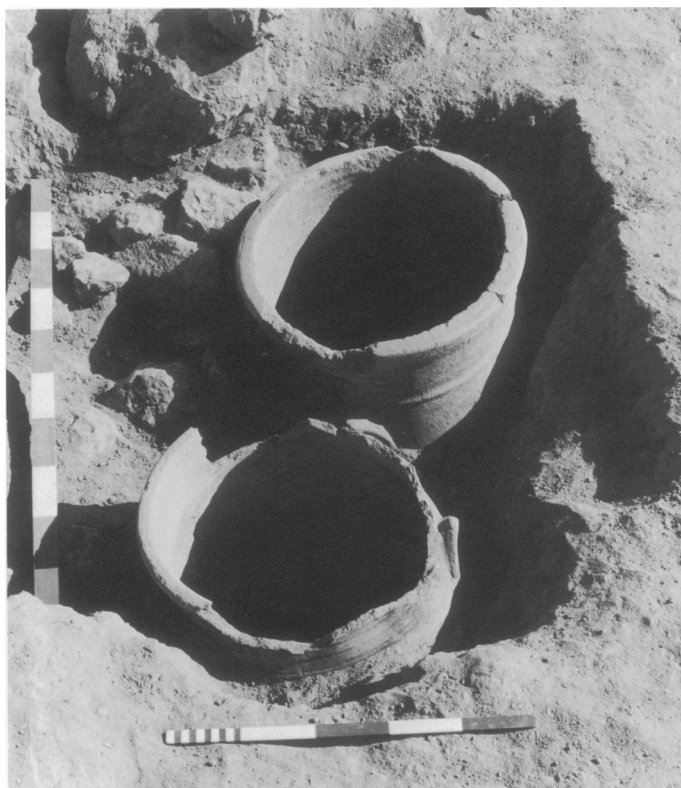
10 Upper City, Trench TT, pithoi in situ (Neg. AM95/08/12)

During the removal of the two pithoi it became clear that the context into which they were cut was the same as a large layer of re-deposited material associated with the reconstruction of the mound prior to the construction of the last Upper City defensive wall. The fact that the kiln also cut this layer, combined with its almost certain association with the pi-
